**HOME
INSPECTION
COLORADO**

Thermography report
Sample report
Pueblo, CO 81003

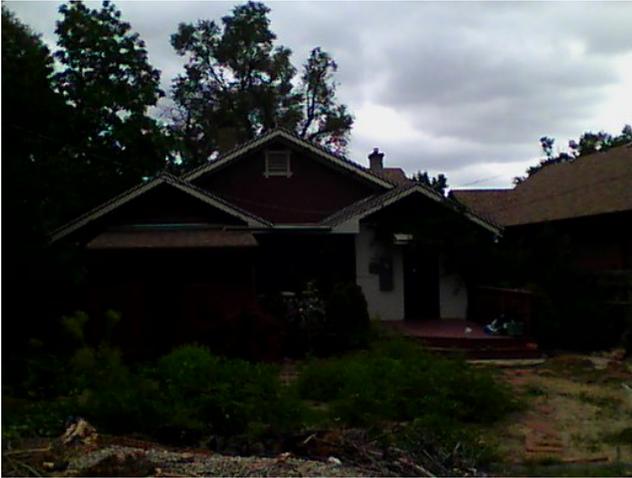
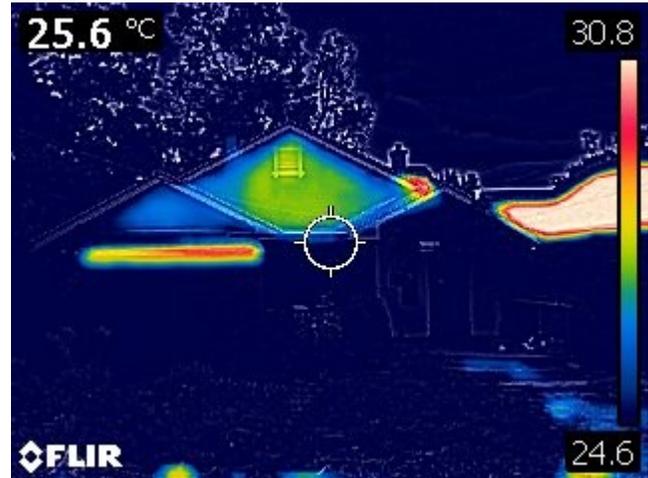
1. Building exterior

The roof shingles and the walkway are directly exposed to the sun and are made in materials that tend to absorb the heat. Thus they show higher temperatures. The attic floor is insulated but the attic roof is not, therefore the attic gets hot while the first floor stays relatively cool.

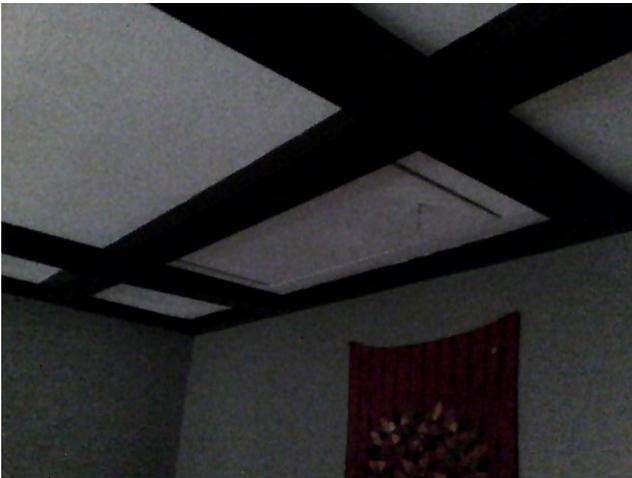
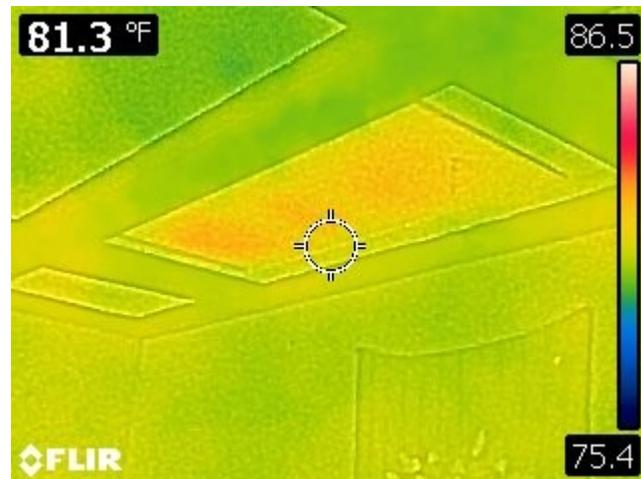
2. Attic access

Attic access is a typical place where the lack of insulation is easy noticeable. Here the attic is warmer than the living room. The ceiling is insulated but the attic access is not, so the attic access is warmer than the rest of the ceiling as it is in direct contact with the hot air in the attic. In the winter, heat is lost through the attic access.

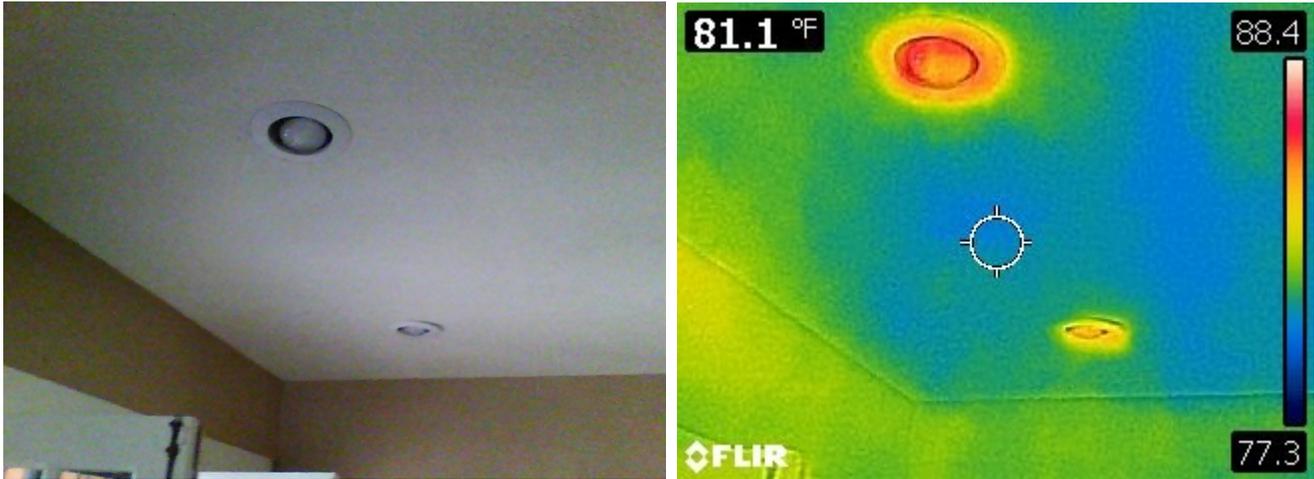
3. Recessed lights

Recessed lights are other typical places where the lack of insulation is easy noticeable. In the winter, this is where all your hot air goes, increasing the heating bills.

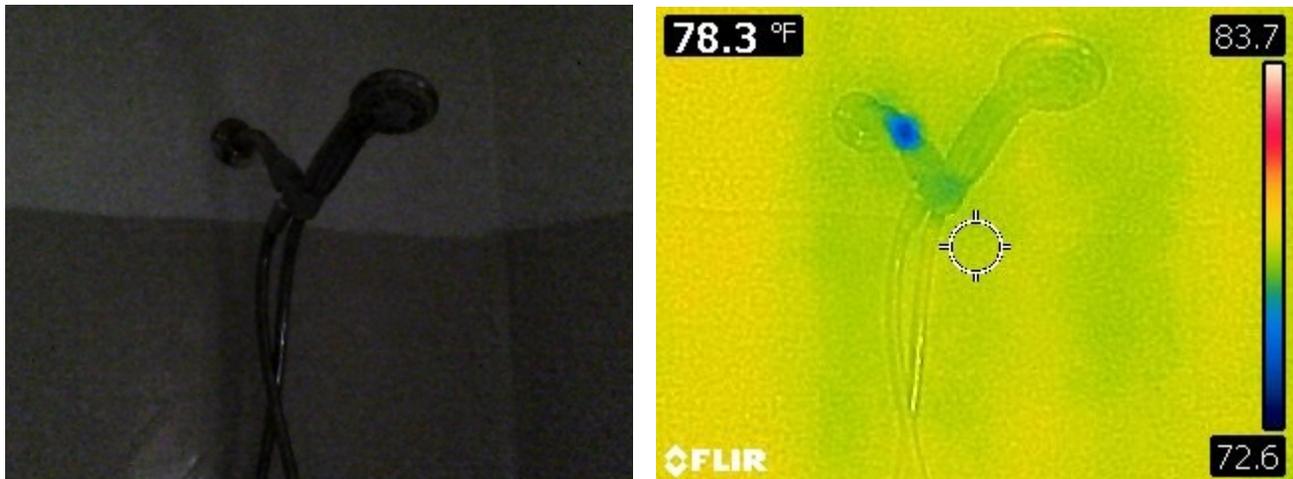
4. Water leakage

Normally the tap water is colder than the ambient temperature, so water leakage like this can be spotted.

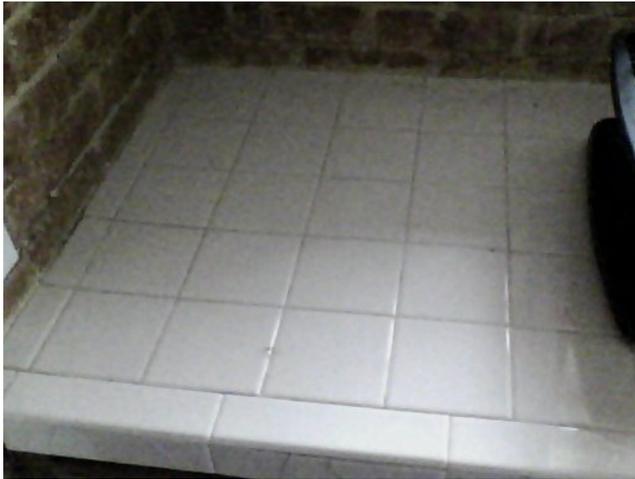
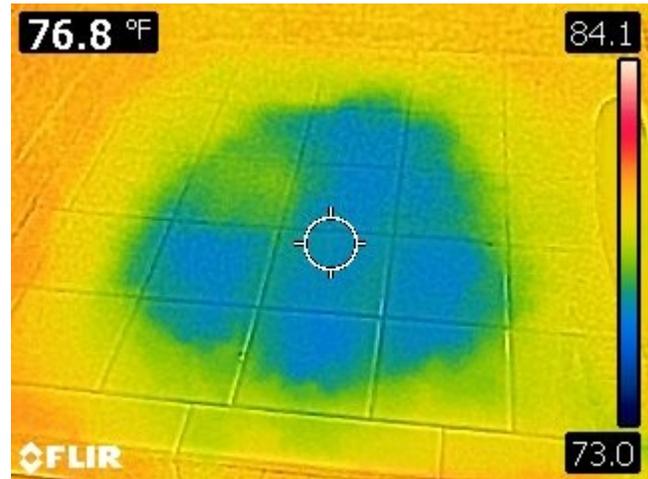
5. Moisture

Infrared technology also allow us to spot moisture where it cannot be seen with the naked eye. Here, I poured some water on the counter top and then dried it with a towel. The remaining moisture is evaporating, that's why the tiles are colder where the water was present.

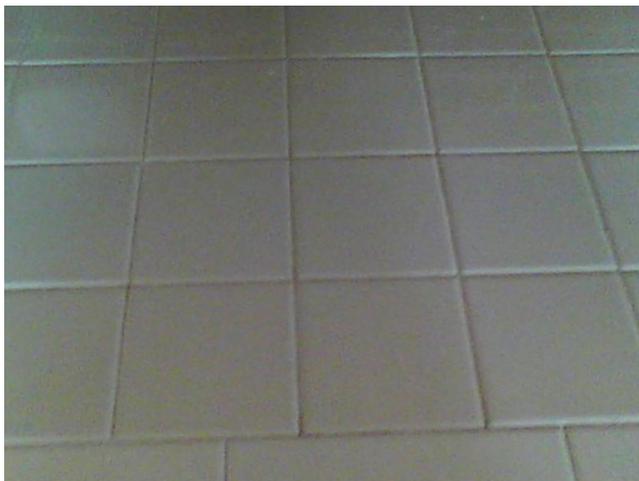
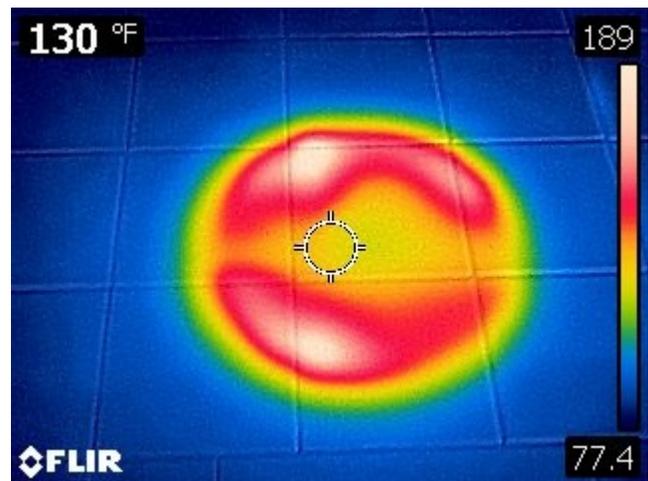
6. Hot spots

Hot spots can be located as well. Here a hot cast iron pan was sitting on the counter-top for a while. Its imprint can be still seen with the infrared camera.

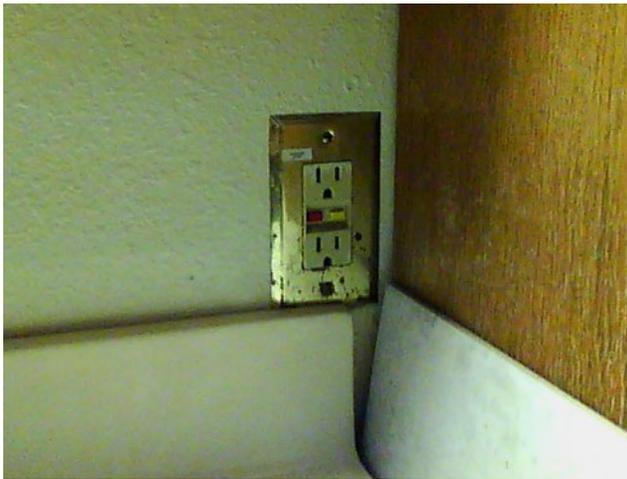
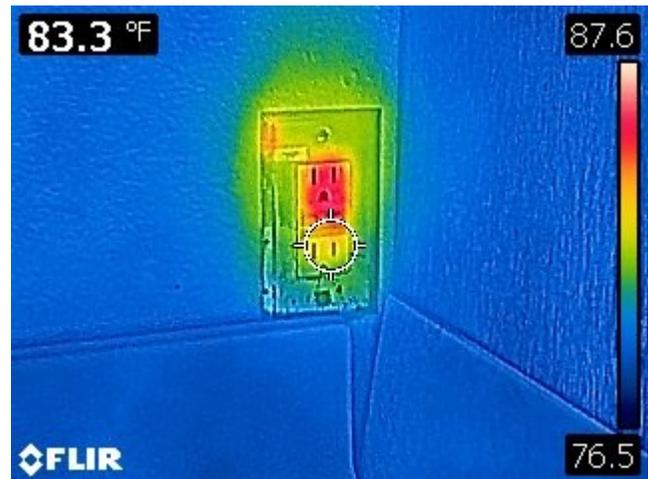
7. Electrical

Infrared is also helpful to diagnose possible electrical problems...

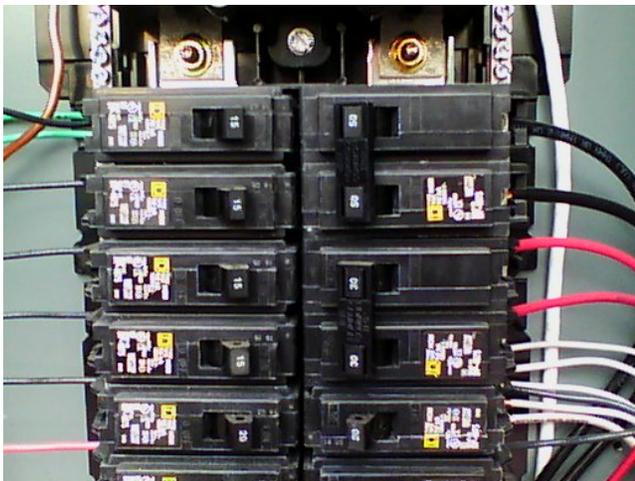
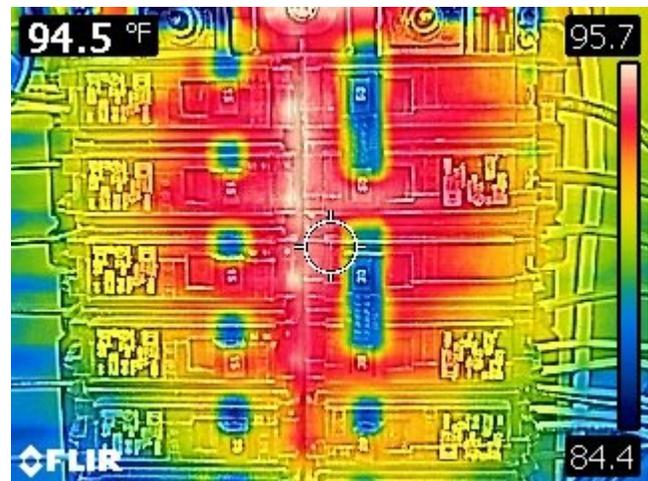
...or to confirm that no overloading is occurring at the breakers.
